Gas processing plant reduces daily hot valve problem with innovative Inlet Integrity Program

CASE STUDY

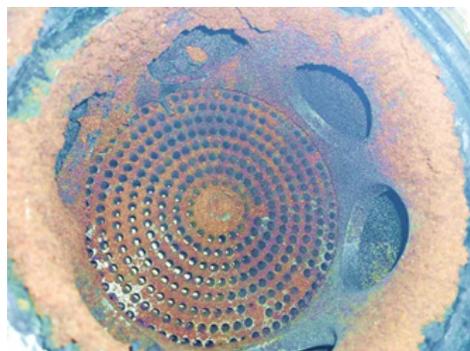
FIGURE 1: A typical compressor valve with fouling.

Figure 1 is a typical valve from the compressors with the fouling that would build up each week. This quickly became the biggest issue on the plant manager's mind.

The plant manager asked Nalco Water to help find a solution to this ongoing issue. The first step was to identify the chemical composition of the deposits. Samples were sent to the Nalco Water Analytical Lab for analysis, and it found that the deposit mainly consisted of salt¹.

¹ Three samples were analyzed, which should an average of 74% NaCl in the deposits.

Nalco Water recommended feeding EC3699A, a compressor antifoulant that is part of the Inlet Integrity Program. This product is engineered to help remove more solids and dissolved salts

The EC3699A² was fed into the pipeline a few feet in front of the inlet separator using an atomizer to ensure proper distribution into the gas stream. Samples of the blowdown water were taken and analyzed for salt content and the plant monitored the compressors to see if there was any change in the maintenance frequency of the compressors.

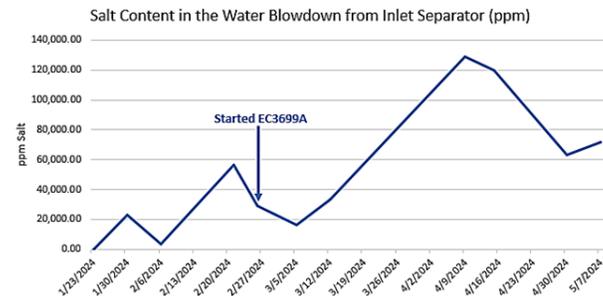
The blowdown samples showed a large salt increase in the water, see Figure 2. The average salt content in the water increased almost 250% from the pretrial samples. This data was a leading indicator that the product was removing the foulant in the inlet separator, preventing it from traveling to the compressors. However, the main criteria of the trial was to see an increase in the period between successive down times and a reduction in the frequency of compressor maintenance.

FIGURE 2: Blowdown samples.

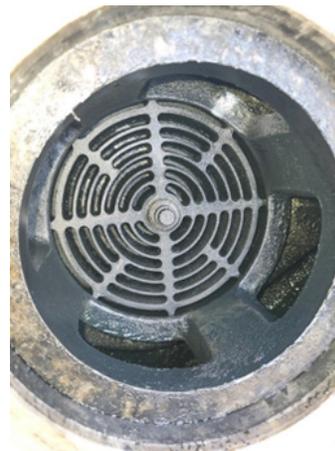
Compressor #7 was chosen as a basis for the trial. Two weeks into the trial, the compressors were showing no signs of issues. The plant manager decided to open up Compressor #7 to see if there was any build up. Figure 3 is the Compressor #7 valve at the time of opening. According to the plant manager, he had never seen a valve this clean after more than three days of use.

FIGURE 3: Compressor #7 valve at the time of opening.

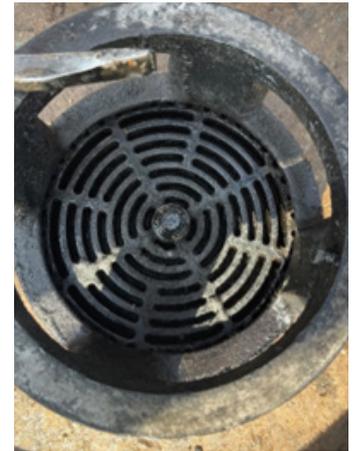
The trial continued without any issues from Compressor #7 or the other compressors for the next 8 weeks. Eventually, the compressor was opened due to a mechanical failure unrelated to the fouling. Figure 4 shows the Compressor #7 valve after ten weeks of chemical feed.

FIGURE 4: Compressor #7 valve after ten weeks of chemical feed.
