OMNI Heat Exchanger Reliability Helps Define Strategy to Avoid Downtime in a Texas VCM Plant

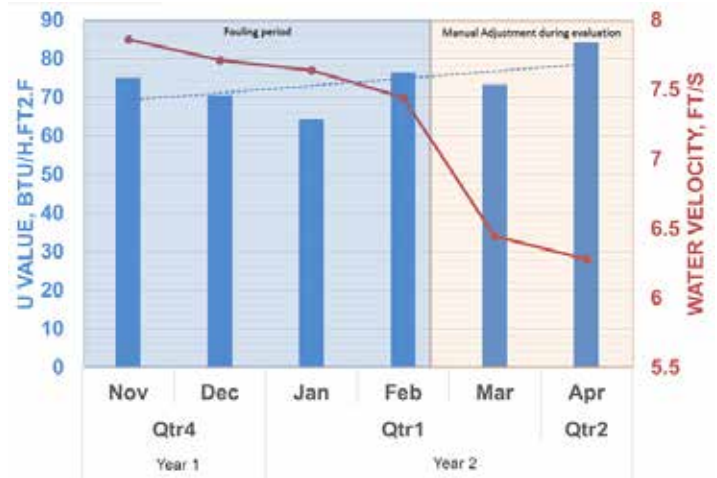
Once installed, OMNI calculated the water velocity and heat transfer coefficient (U value) on a continuous basis. During the first four months of operations, OMNI data identified a consistent cooling water flow decrease with no measurable impact on heat transfer efficiency (see figure 1).

Figure1. Variations of U value and Water velocity inside the Heat exchanger

OMNI™ data also discovered that this heat exchanger was using approximately 25% greater-than-design cooling water flow. The OMNI-calculated U-Value trends didn't show any significant decrease in heat transfer. Therefore, it was decided by Nalco Water and the customer to manually reduce the cooling water flow to the propylene condenser and redirect the excess flow to other heat exchangers in need. In addition, OMNI identified potential savings that could be realized by installing variable frequency pump drives, if the customer decided to reduce the circulating water on the system. Variable frequency (flow) pumps allow the most efficient use of pump motor energy consumption, considering the excess of water used on this heat exchanger.

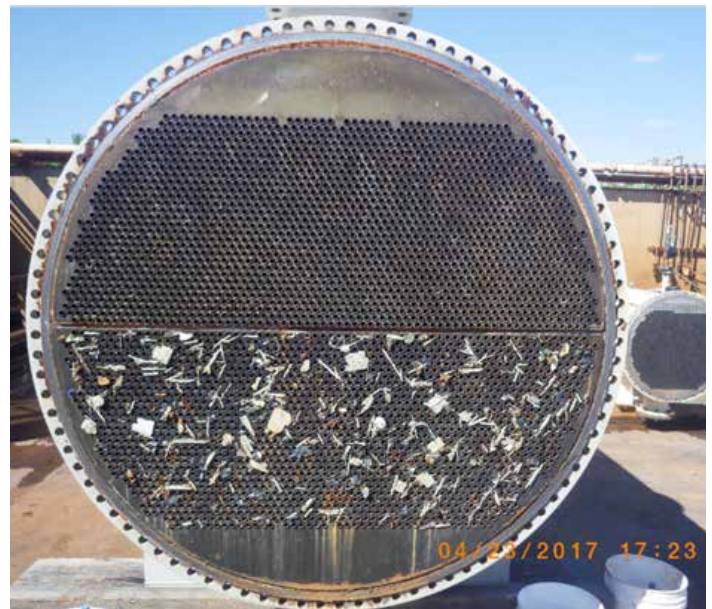
Based on the historical issues at this site, it was anticipated that the cooling water inlet tube sheet likely had accumulated debris restricting the cooling water flow. This accumulation of debris was confirmed during the turnaround. See photographs of EA2281B Tube sheet, (see Figure 2.)

Figure 2. Debris in the inlet of critical heat exchanger.

The ability to “visualize” the condition of a heat exchanger allows production personnel to implement proactive corrective actions at times most convenient to site operations. During the inspection, no significant scale or deposition was observed, and the tubes and tube sheet were in a favorable condition. Nalco Water and the customer had discussed installing strainers to minimize the debris issue. Strainers were installed in 2017 and now provide an improved solution to the debris fouling.
