Questions and Answers

STEAM SYSTEM DEPOSIT

Cyclohexylamine Carbonate and Bicarbonate

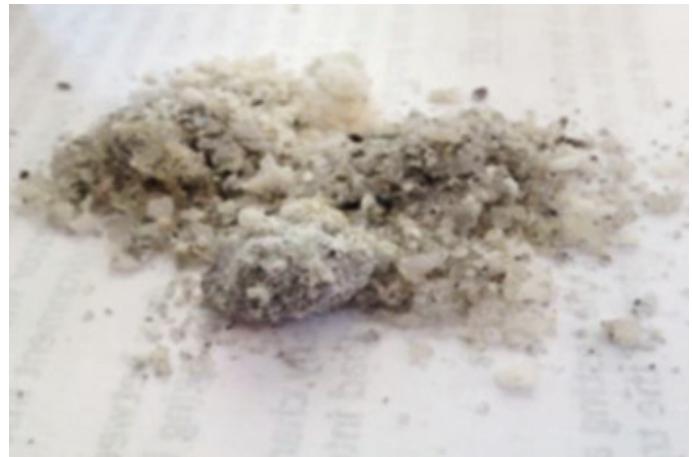
The first thought is that it might be the result of boiler water carryover, but the key observation is the odor from the deposit. When conditions are right in steam systems, cyclohexylamine carbonate or cyclohexylamine bicarbonate deposits can accumulate. When sampled, these deposits smell a lot like ammonia. The deposit is generally a very white, crystalline or granular material. Figure 1 shows a picture of this material.

The cause of cyclohexylamine carbonate or bicarbonate deposits in steam lines is a concentration mechanism. You see this most often in the normal installation of a pressure or temperature control instrument or heat tracing lines. The take-off point for these is typically off the top (vapor space) of a line. In these situations, the sampled space is a steam environment. Condensate may form in this area, but CO₂ and cyclohexylamine will tend to stay in the steam space. As this continues and concentrations exceed solubility limits, desublimation leads to crystal formation in no flow areas. Vertical take-offs and vertically positioned lines are more prone to plugging because there is a smaller area to plug compared to a horizontal line.

These deposits will only form in steam systems treated with cyclohexylamine. Additionally, the higher the alkalinity, the faster the deposits can accumulate.

Figure 1 - Sample of a steam system deposit that was analyzed to be cyclohexylamine carbonate.

Deposits can be removed mechanically from affected areas, depending on access and the degree of deposition. A typical approach would be to replace the appropriate section of pipe.

There are a number of remedies to consider to minimize or eliminate the condition.

- **Repipe lines to remove the concentrating mechanism**
- **Maintain temperatures above sublimation with a slow steam bleed or pipe insulation**
- **Switch to steam treatment without cyclohexylamine (or with reduced levels)**
 - *Tri-ACT™ 1840* is one optimized chemistry option to consider
- *Blow out lines weekly or biweekly before deposits have a chance to build*
- *Reduce alkalinity (CO₂) present by reducing makeup water alkalinity*
